Press Release May 31, 2018

Lula Restaurant Distillery Reduces Odor with AirMaid

New Orleans Restaurant first ever in Louisiana to use ozone technology

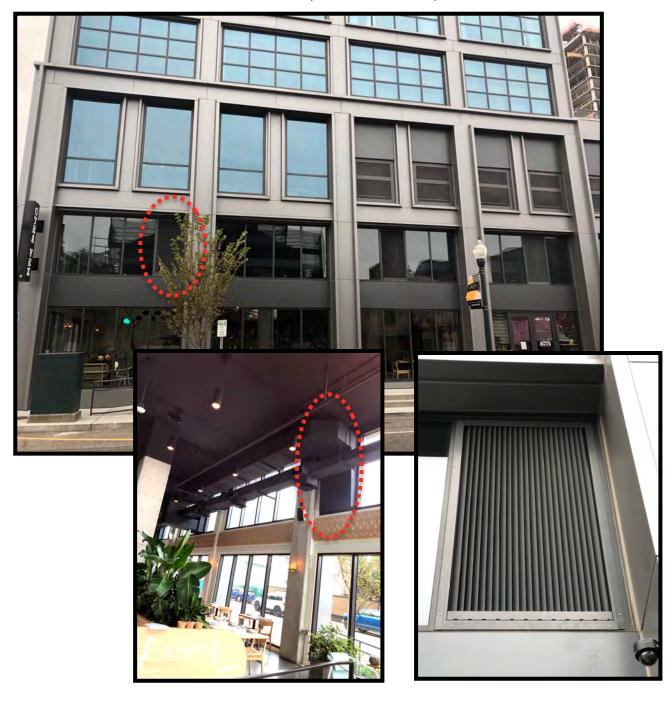
Otra Vez, New Orleans, LA

On November 14, 2019, while visiting with our manufacturer's representative, Air-Side Equipment Inc., we inspected the sidewall louvres of two installations in downtown New Orleans. As can be observed in the followoing photograhs, there is no grease visible at the discharge points of either restaurant, both which have been operating for at least one year.
